## PWD, VCAP & ANEITYUM AC

### RESULTS & RECOMMENDATIONS FROM VULNERABILITY ASSESSMENTS & COMMUNITY ENGAGEMENT

#### *Recommendations for PWD: Aneityum AC*

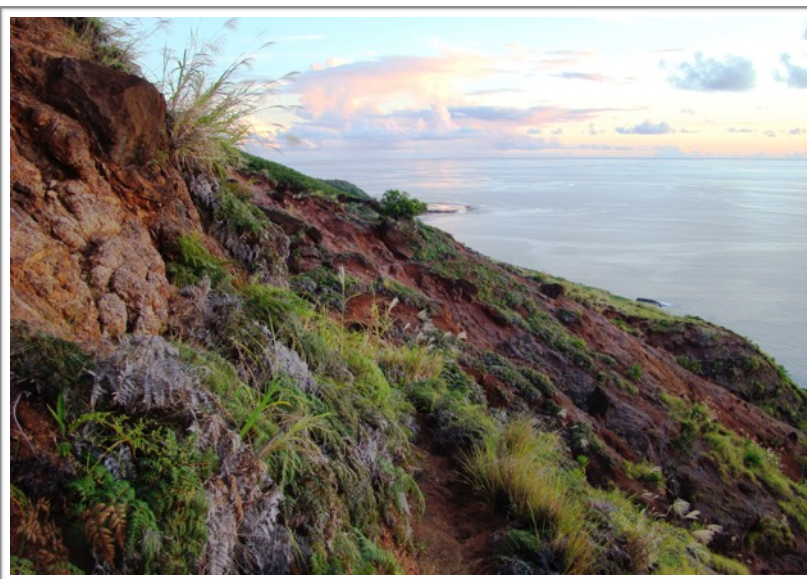
*(Above: Footpath passes over a large, steep hill in Anaowanse with severe erosion)*

A **large, steep hillside located near Anaowanse** consisting of a red, clay soil is the largest obstacle obstructing access to Anelcauhat. In rainy conditions, the footpath here can be very dangerous, especially for women, children and the elderly. To avoid this hillside, some villagers were scaling across a cliff with a sheer vertical face that is located approximately 20 meters above the ocean until the local chiefly council forbid locals from using this route due to the potential danger from falling. Community members request assistance in improving the building materials and design of the footpath at this dangerous area, perhaps installing stairs, drainage, railing and using soft measures such as vetiver grass to minimize erosion.

- Engineer from PWD to inspect footpath and create technical plan for "climate proofing" of primary footpath Q2 2016
- Focus on specific areas of primary footpath (*not secondary paths used for gardens, etc*)

- Soft measures such as vetiver grass and planting of trees to curb erosion and utilize vetiver grass nurseries in Anelcauhat & Anawamet
- Update communities & VDC's regarding status of previous PWD scoping missions relating to road

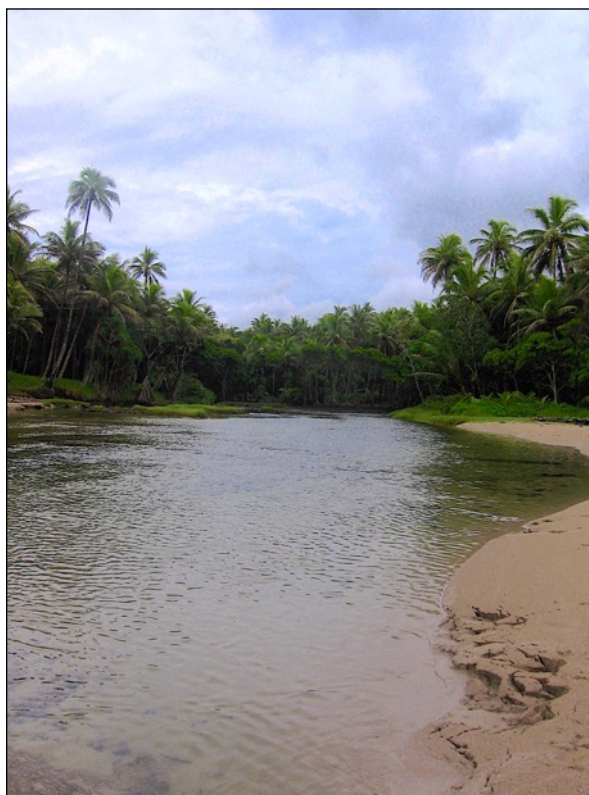
As soon as you leave the center of Anelcauhat Village and proceed towards Aniplatei there is a large river that must be crossed. Recommended that a pedestrian crossing be constructed several hundred meters inland from the mouth of the river due to coastal

erosion / storm surge impacts at the mouth of the river. This is **biggest vulnerability on the access way as reported by Anelcauhat VDC and should be a priority item for delivery.**

*(Above: Largest river in Anelcauhat, at river mouth)*

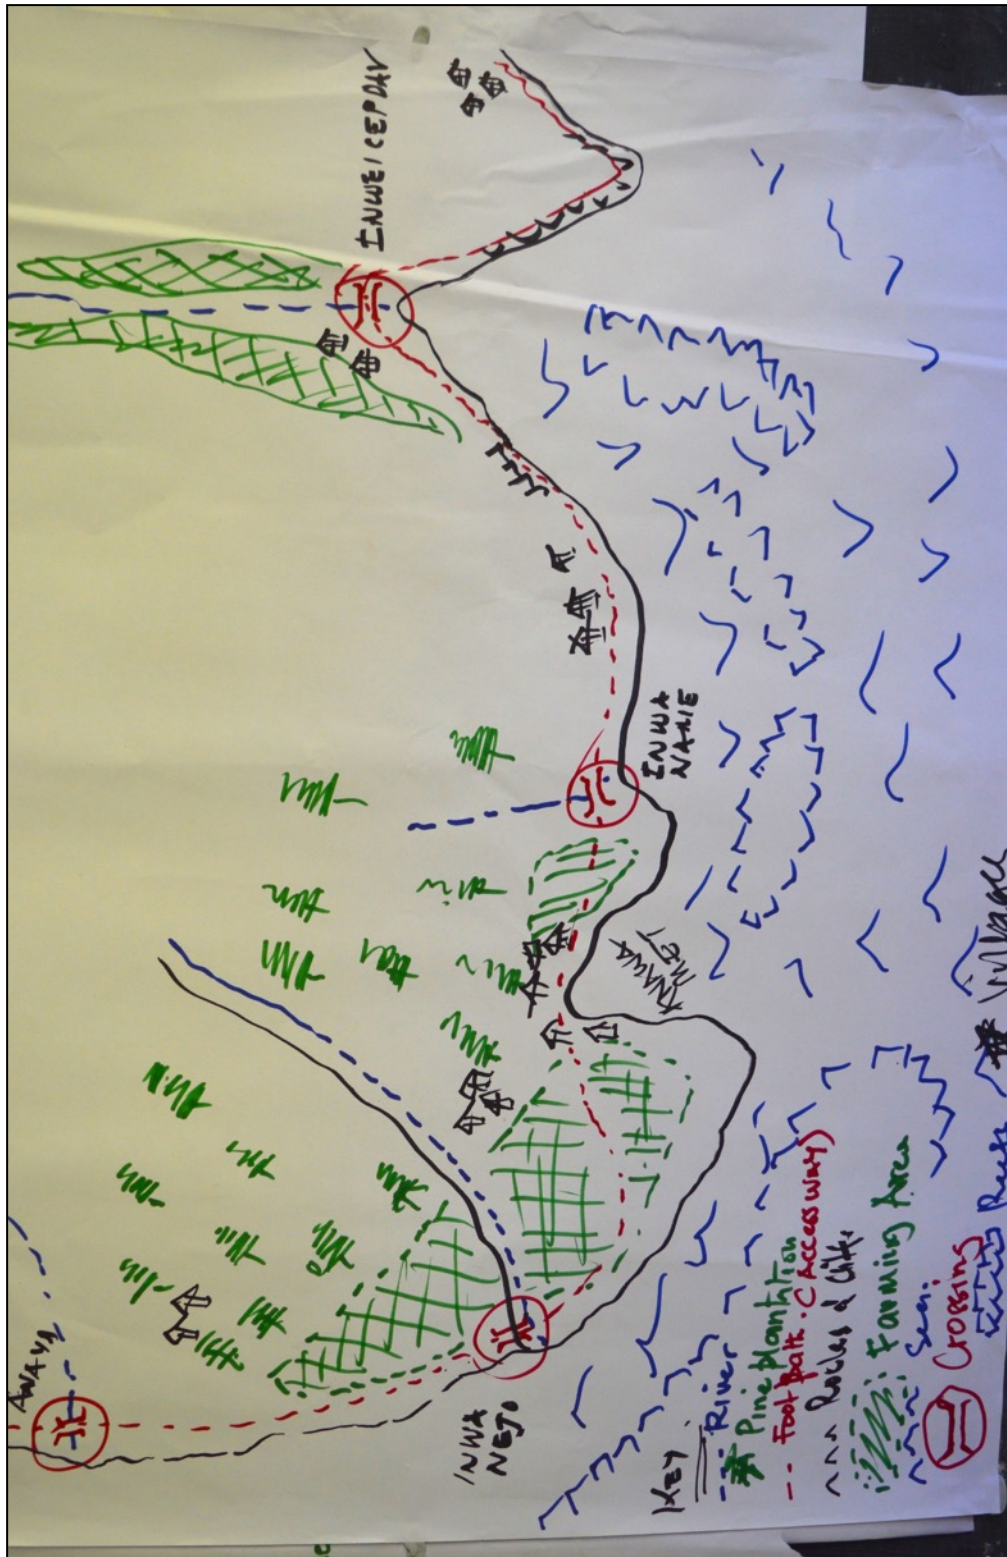
## Anaowanje - Anawamet - Anaowanse; Community Mapping of Footpath Vulnerabilities

Community mapping exercise showing climate related vulnerabilities as indicated by community along the footpath from Anaowanje to Incedav. Dotted red line denotes location of primary footpath, dotted blue lines denote river and creeks and red circles indicate river and creek crossings
