# PWD, VCAP & NORTH ERROMANGO AC

## RESULTS & RECOMMENDATIONS FROM VULNERABILITY ASSESSMENTS & COMMUNITY ENGAGEMENT

### *Recommendations for PWD: North Erromango AC*

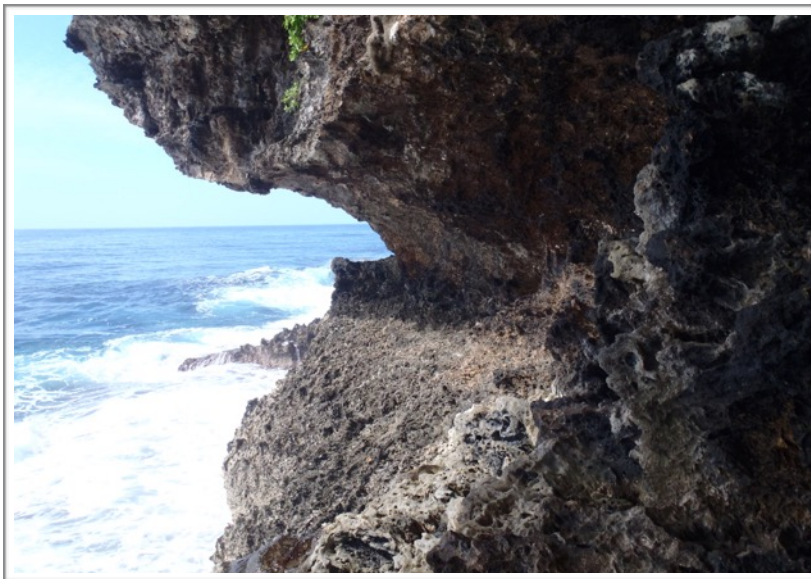
*(Above: coastal footpath between Ipota and Cooks Bay)*

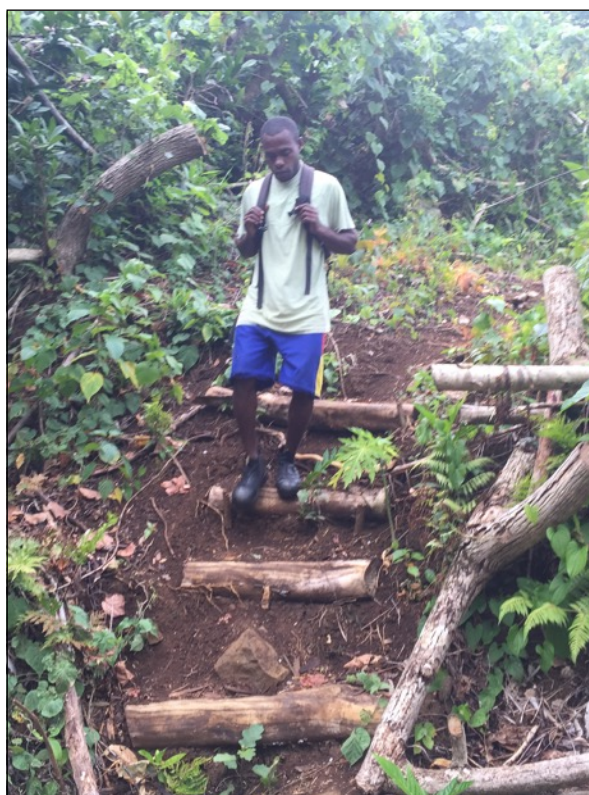
*(Above: upland footpath between Cooks Bay and Port Narvin where locals have attempted to install stairs)*

community of Port Narvin, the footpath experiences moderate erosion as it passes through hillside gardens. A wild bushfire in October, 2015 consumed large swaths of nearby vegetation and trees, which will result in further erosion according to locals.

Recommended that the upland footpath between Cooks Bay and Port Narvin be inspected by a specialist who can recommend interventions. This is **second biggest vulnerability on the access way as reported by North Erromango VDC and should be a priority item for delivery**.
